10078 - 10079

VW TRANSPORTER T5 05/2003 >

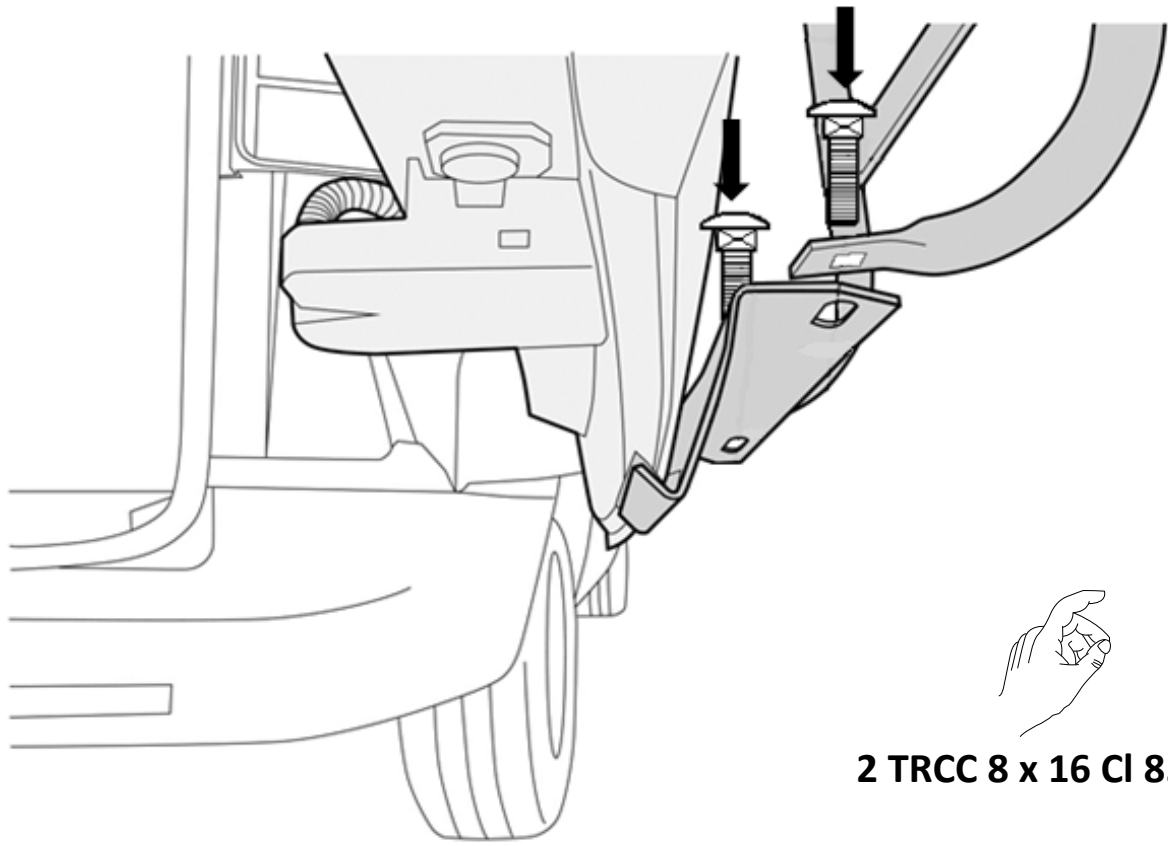
2 TRCC 8 x 16 CI 8.8

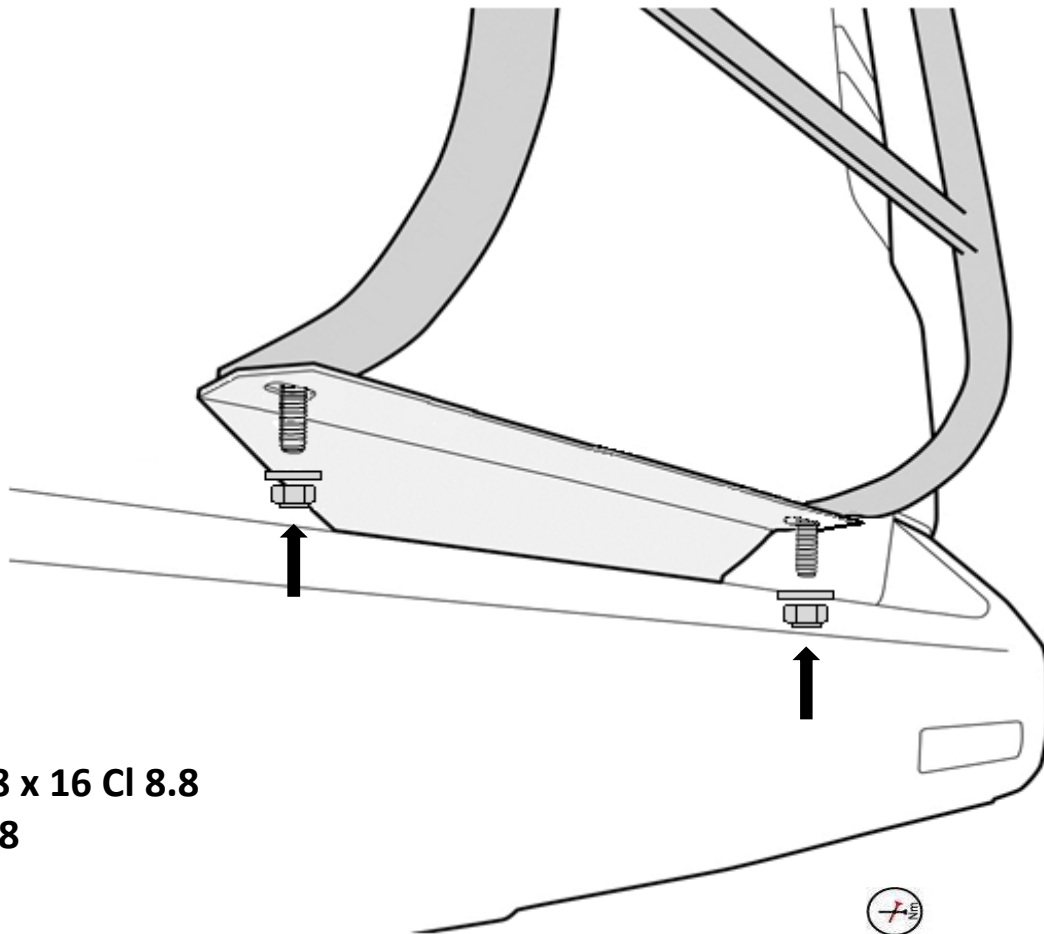
2 TRCC 8 x 16 CI 8.8

2 L 8 x 18

2 M8

23 Nm
